UNDERGRADUATE HONOURS THESIS

**STRENGTH AND RELIABILITY OF
CHEMICALLY BONDED ROCK CLIMBING
ANCHORS IN SANDSTONE**

DEPARTMENT OF CIVIL ENGINEERING

The University of Sydney

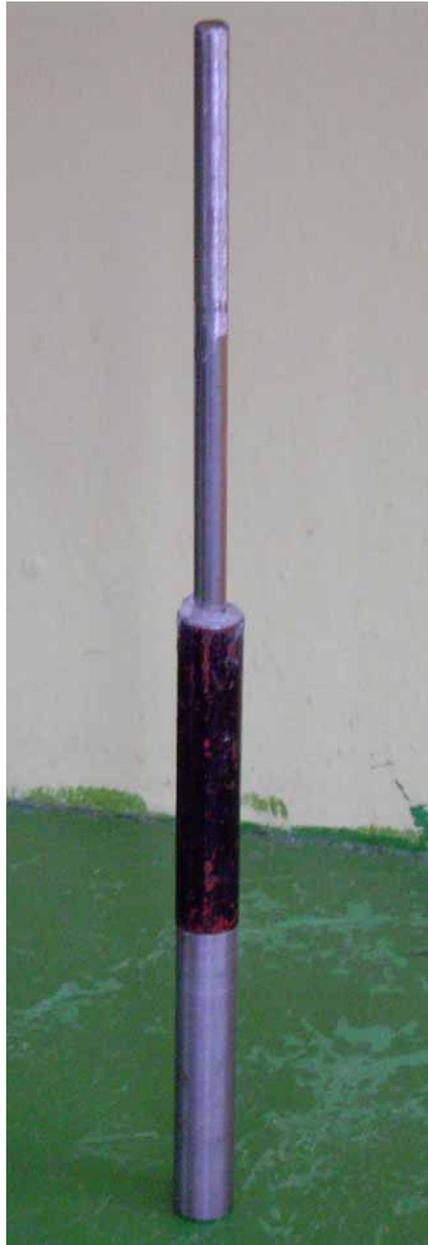
Figure 4.4

The grouted shaft treatment specimen before testing

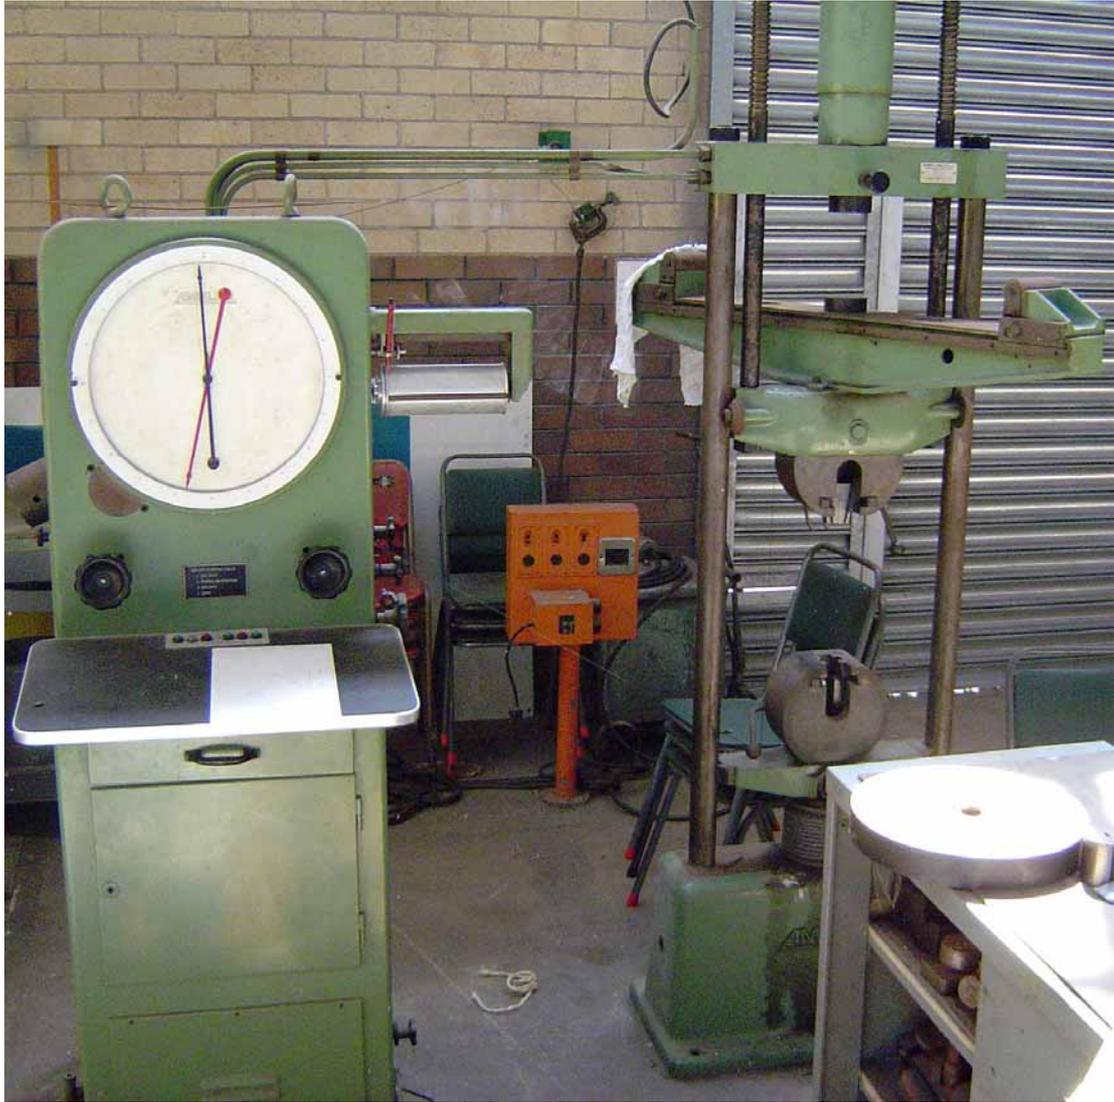
Figure 5.1

Amsler machine used for testing shaft treatment specimens

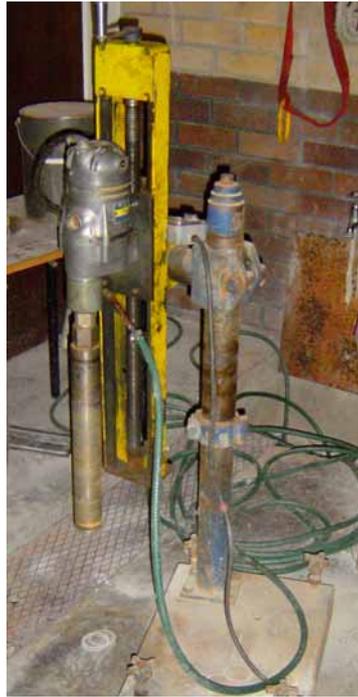
Figure 5.2

The diamond tipped rock core drill

A diamond tipped rock core drill, shown in Figure 5.2, was used to core a sample of the sandstone blocks to be tested. These were then tested in an Avery testing machine as shown in Figure 5.3.

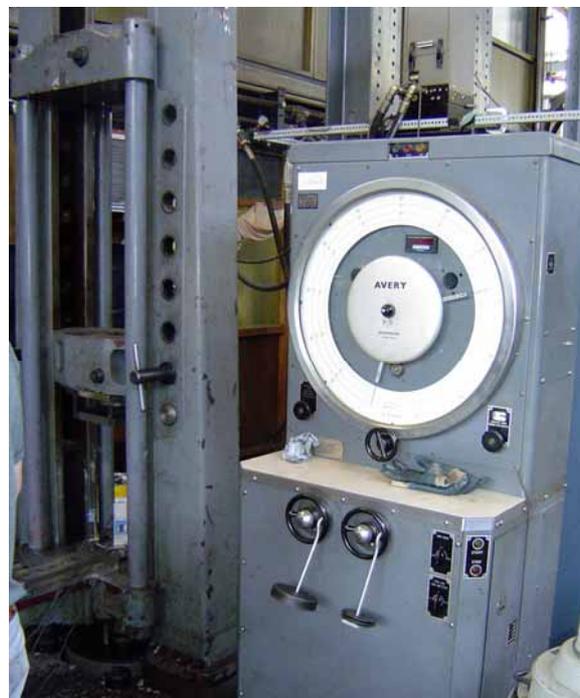
Figure 5.3

The Avery machine used in the unconfined compressive strength tests

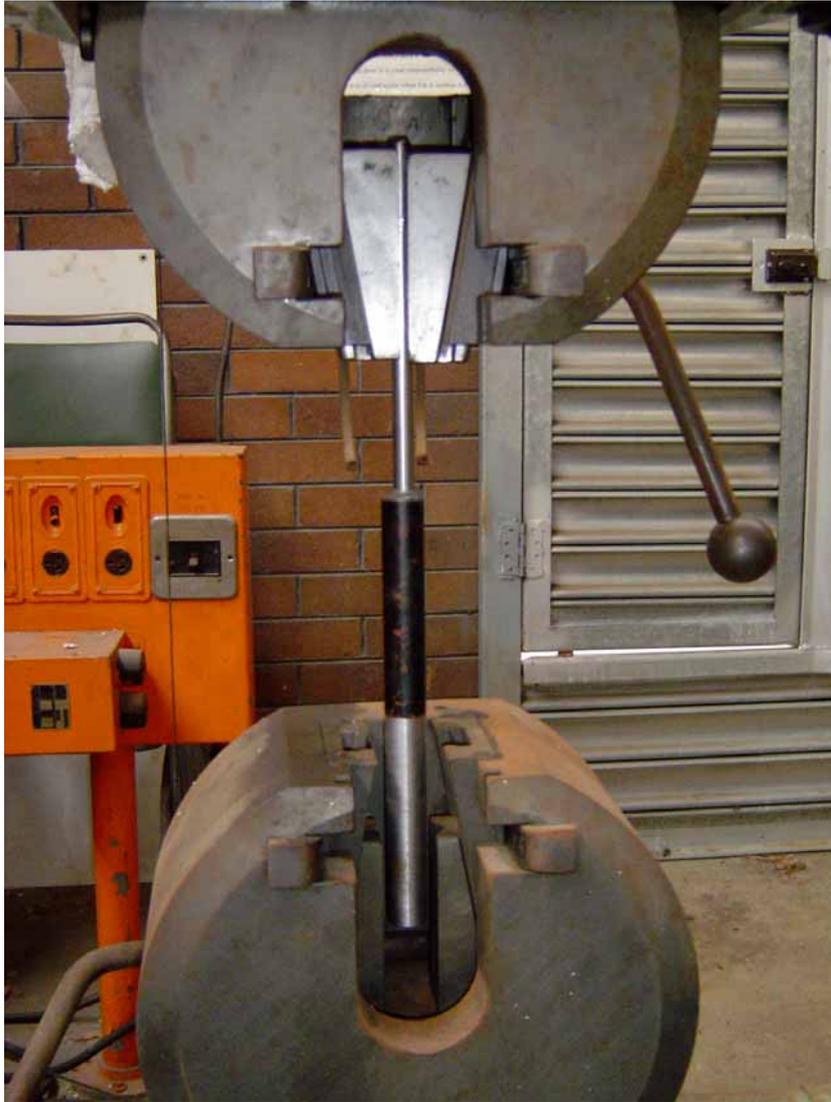
Figure 5.4

Shaft treatment specimen in machine prior to testing

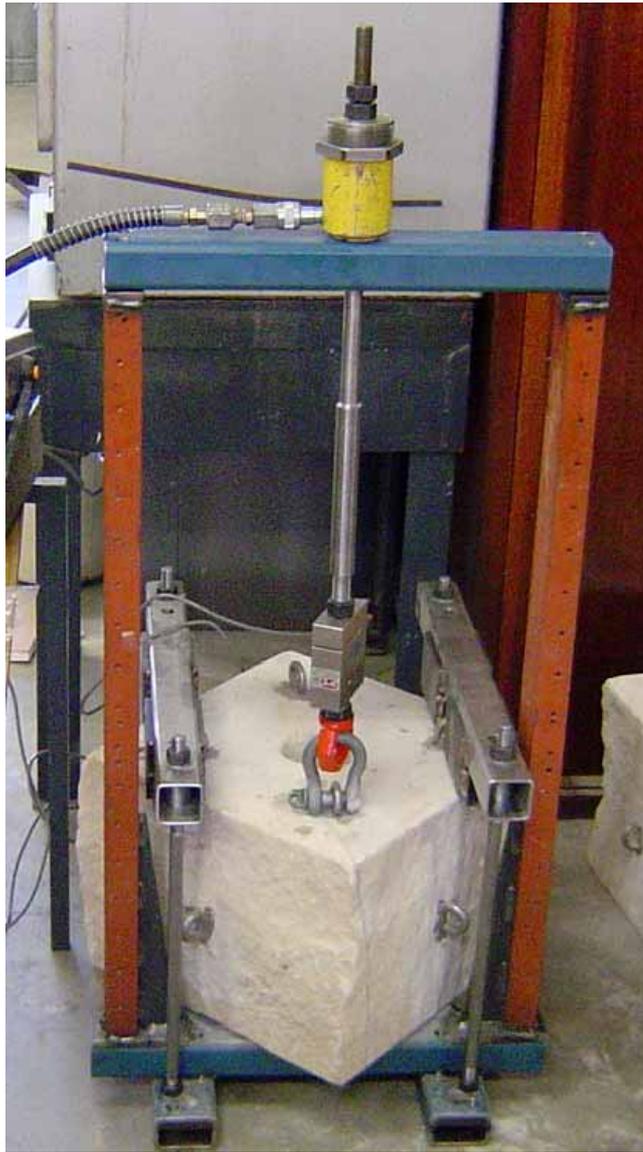
Figure 5.5

Test rig setup for tension testing

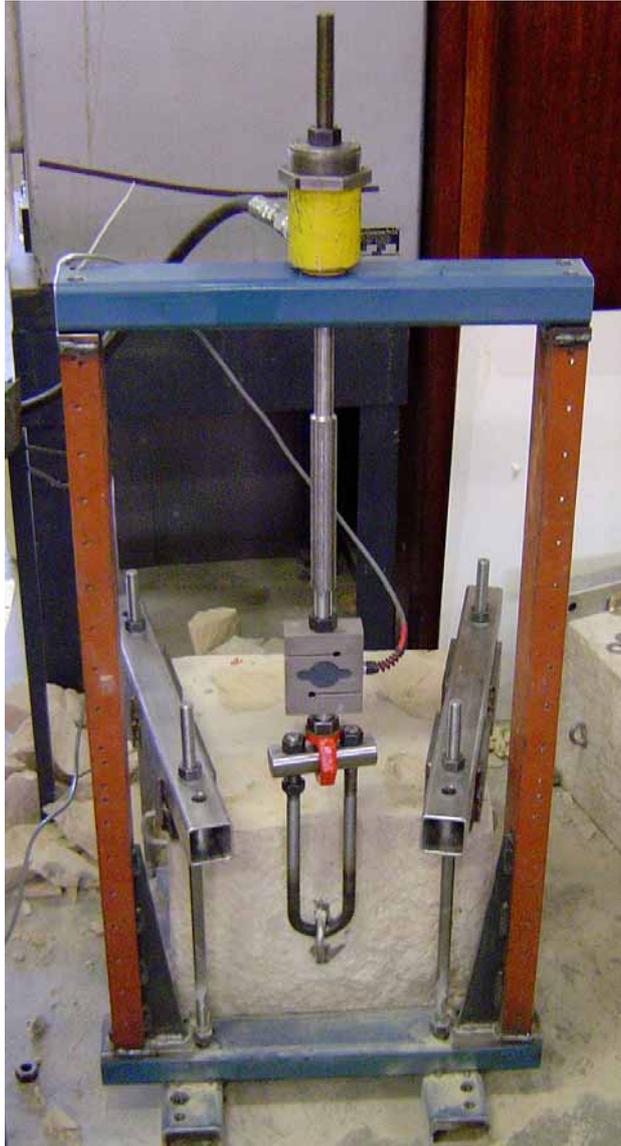
Figure 5.6

Test rig setup for shear testing

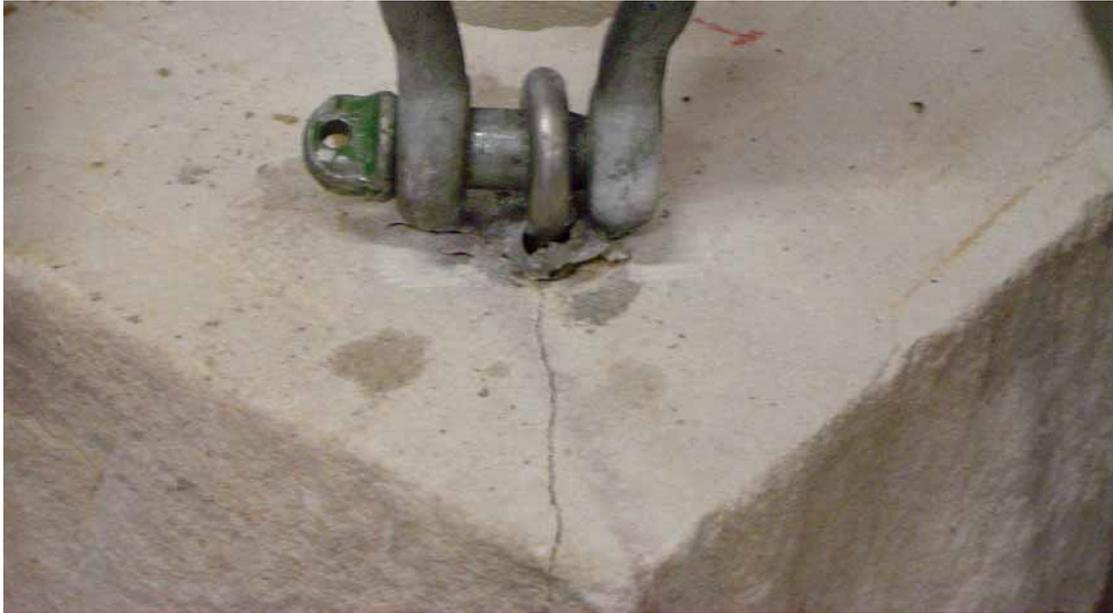
Figure 6.3

Cracking around a ring bolt after failure in tension test

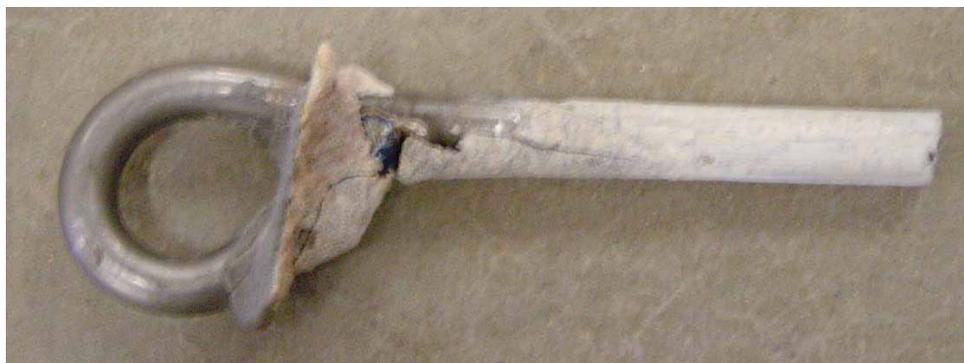
Figure 6.4

Ring bolt after being extracted from a tension test

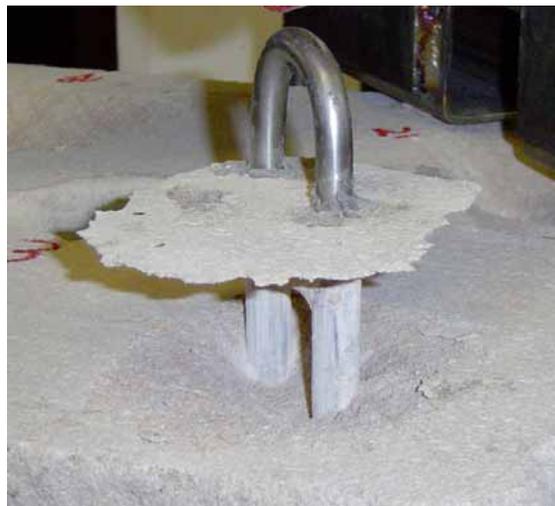
Figure 6.6

45mm U-Bolt tension failure displaying the shallow cone failure and sandstone/adhesive bond failure

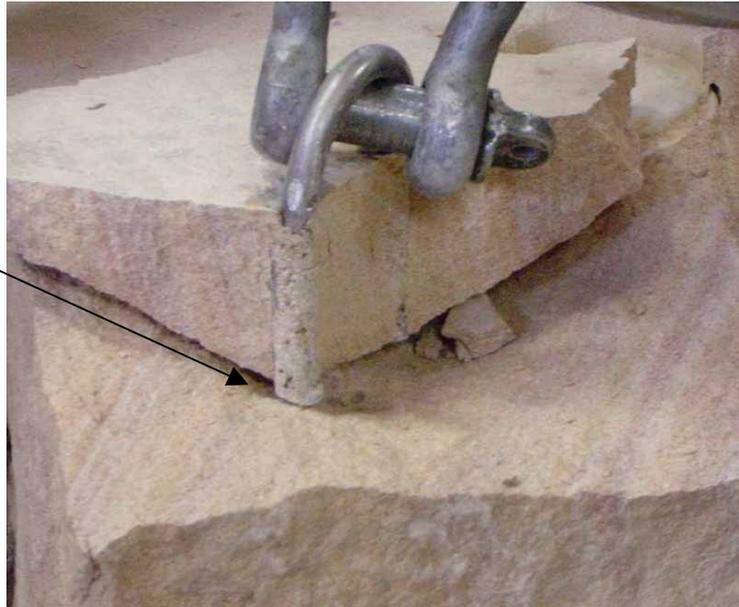
Figure 6.7

Slab of
sandstone
detached
at depth
of anchor

*55mm U- Bolt indicating the depth of sandstone removed relates to depth of the shaft
embedment*

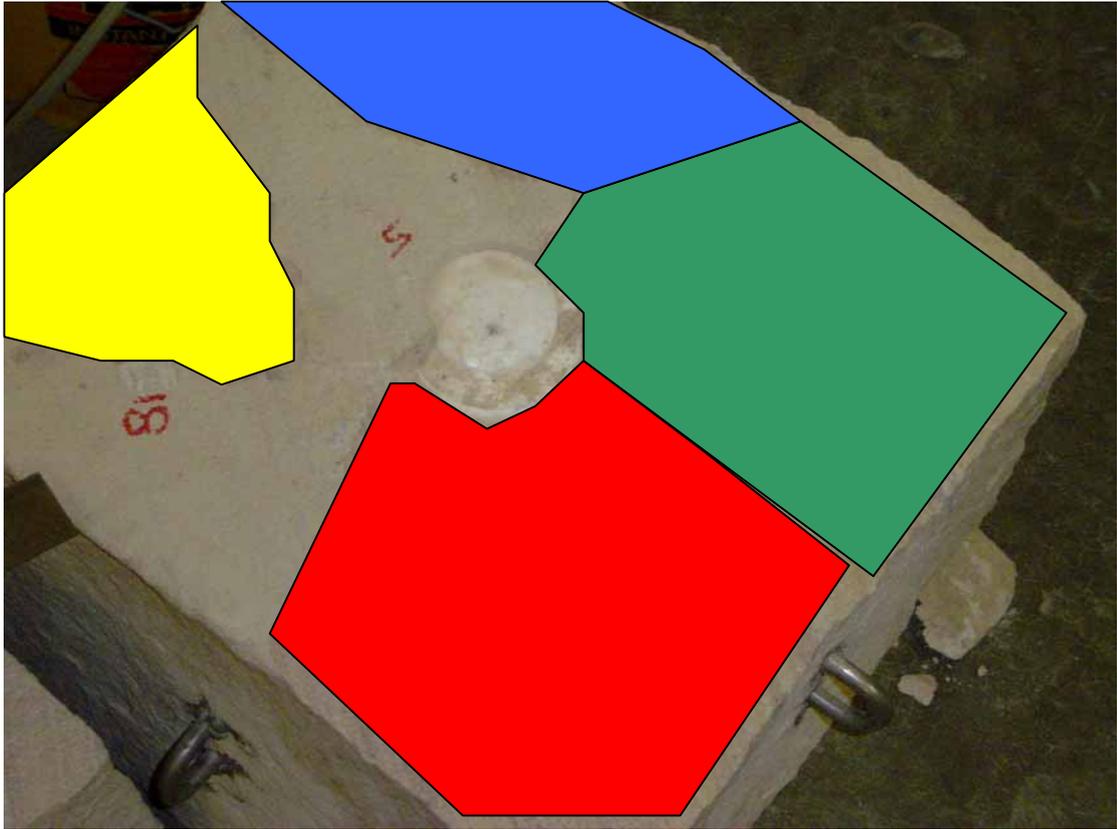
Figure 6.8

Area removed by 55mm U-Bolt tensile tests. The different colours represent the different areas affected by each anchor.

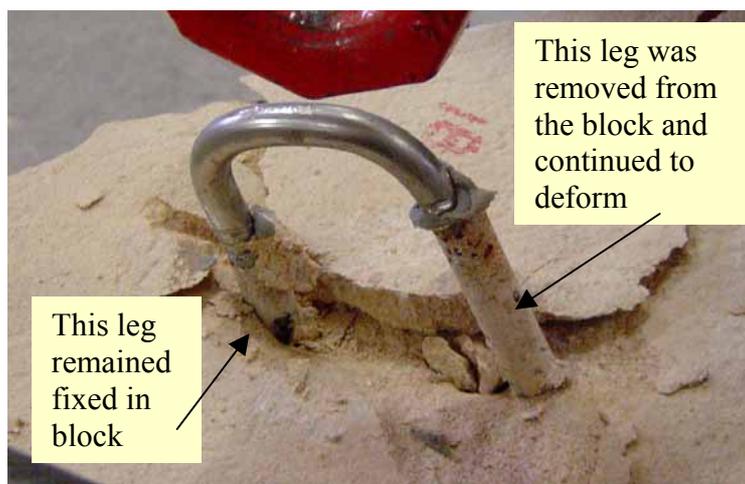
Figure 6.9

55mm U-bolt that failed by sandstone/adhesive failure and deformed

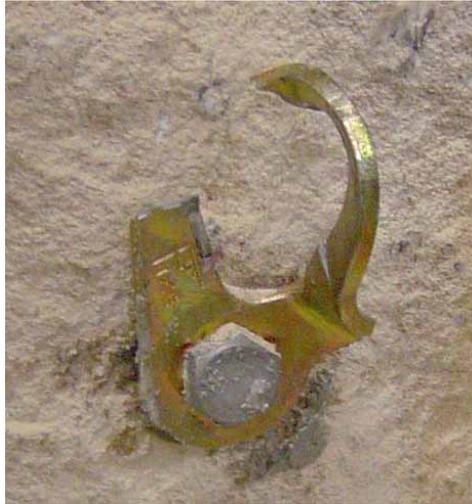
Figure 6.18

Failure of the hanger on the machine bolts during the shear test

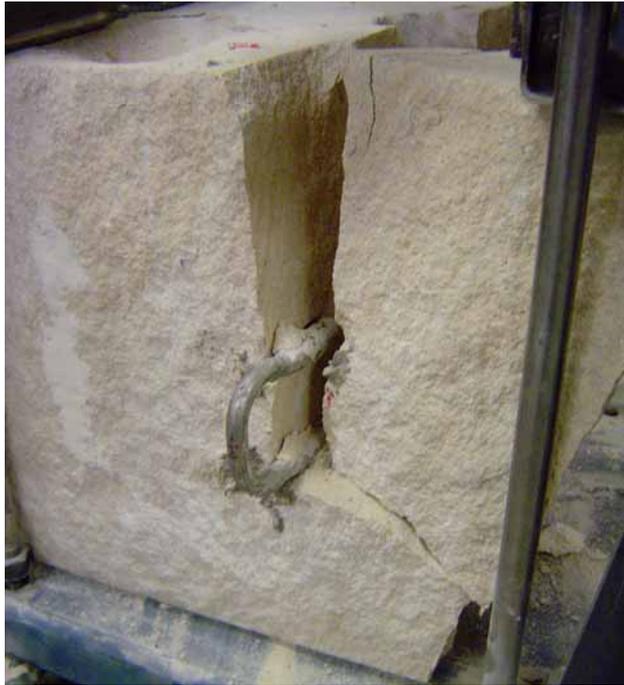
Figure 7.2

Test 26 failed due to the close edge distance
